Manhole Inspection Summary

Manhole # S27M__010MH

Insp Date: **4/30/09 2:47 PM**

Location Address: **1200 CARROLL ST**

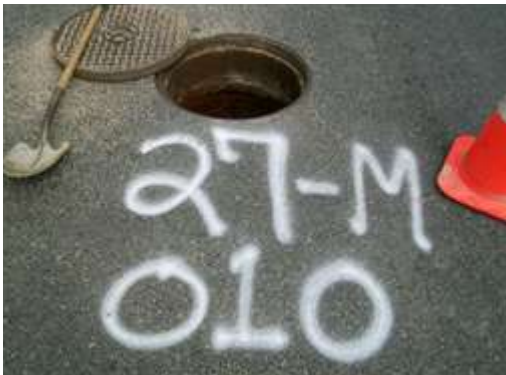
Miscellaneous

PAVEMENT MARKED

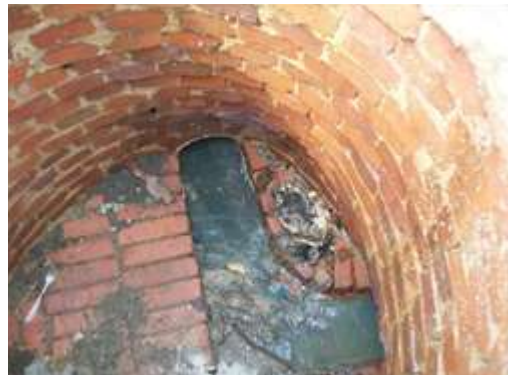
Defect 1

Condition: ☐ Sound ☐ Cracked ☐ Root Intrusion ☐ Deteriorated ☐ Leaks ☒ **Debris**

channel & bench debris

Comments **REMOVED DEBRIS**

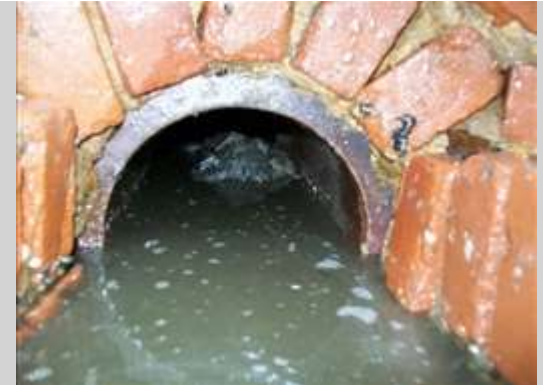
12 O'Clock Outflow

8 in. Circular Gravity Sewer
Pipe Out @ 12 O'Clock

Pipe Height: **8.4** (in.) Rod and Bar (Angled)
Pipe Material: **Clay** ☐ Pipe Lined
Invert Depth: **5.80** (ft.) Flow Characteristics: **Slow**
Deposits: ☒ None ☐ Mud ☐ ~~Sludge~~ ☐ Debris ☐ Grease
Silt Depth: **0** (in.) Deposits Extent:
Infiltration: **None** Pipe Seal Cond: **Sound**

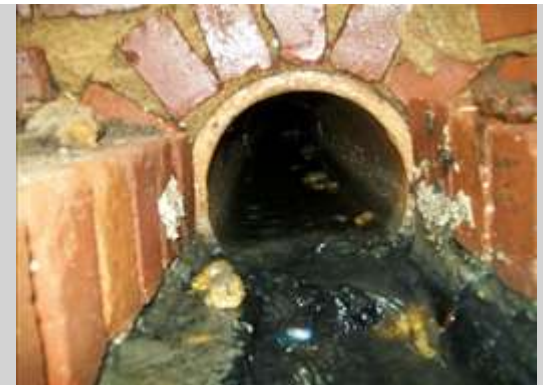
9 O'Clock Inflow

8 in. Circular Gravity Sewer
Pipe In @ 9 O'Clock

Pipe Height: **8.4** (in.) Rod and Bar (Angled)
Pipe Material: **Clay** ☐ Pipe Lined
Invert Depth: **5.75** (ft.) Flow Characteristics: **Slow**
Deposits: ☐ None ☐ Mud ☒ ~~Sludge~~ ☒ Debris ☐ Grease
Silt Depth: **2** (in.) Deposits Extent: **Light**
Infiltration: **None** Pipe Seal Cond: **Sound**
